Shoalhaven Starches, Independent Odour Audit (2021-2022)

Report Reference: 22.1126.FR1V1

Date: 20 October 2022

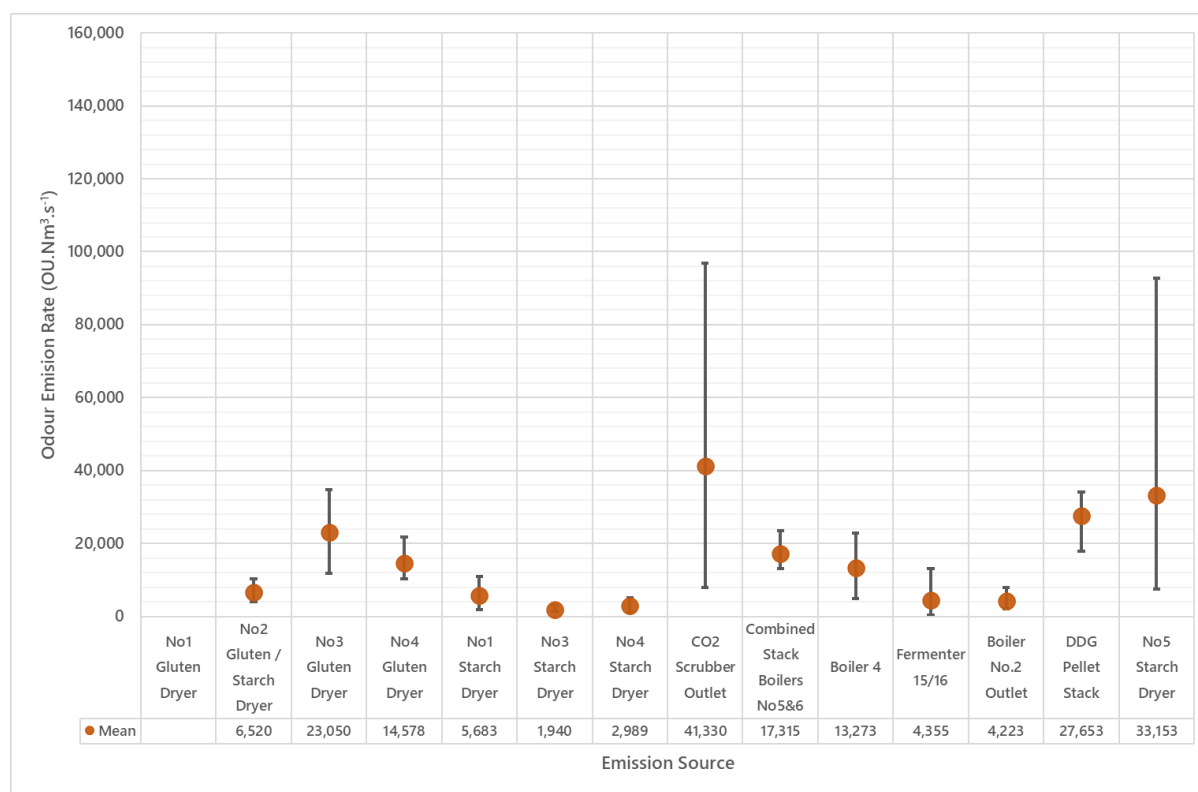
Figure 2 Variation in measured emission rates (range and mean)S

The variation in odour emission rates, as range (represented by the observed minimum and maximum) and the arithmetic mean is illustrated in **Figure 2**.

It is noted that for a number of emission points there is a noted significant variation in the rate of odour emissions (presented as $OU \cdot Nm^3 \cdot s^{-1}$), notably:

- EPA ID 16 (CO₂ Scrubber Outlet) × 12.2
- EPA ID 44 Fermenter 15/16 × 33.8
- ID 47 No 5 Starch Drier of × 12.3

As noted in the previous independent odour audit reports, the atypical odour emission profile highlights an inherent potential variability in the emission rate subject to process operations. It is further noted that the odour measurement uncertainty, as performed in accordance with AS4323.3 and AS4323.4 is (generally) within the range of $0.70U < OU < 1.40U$. The Ektimo test reports present upper and lower uncertainty limits for odour measurements which confirms this uncertainty (at the 95th percentile confidence limits).

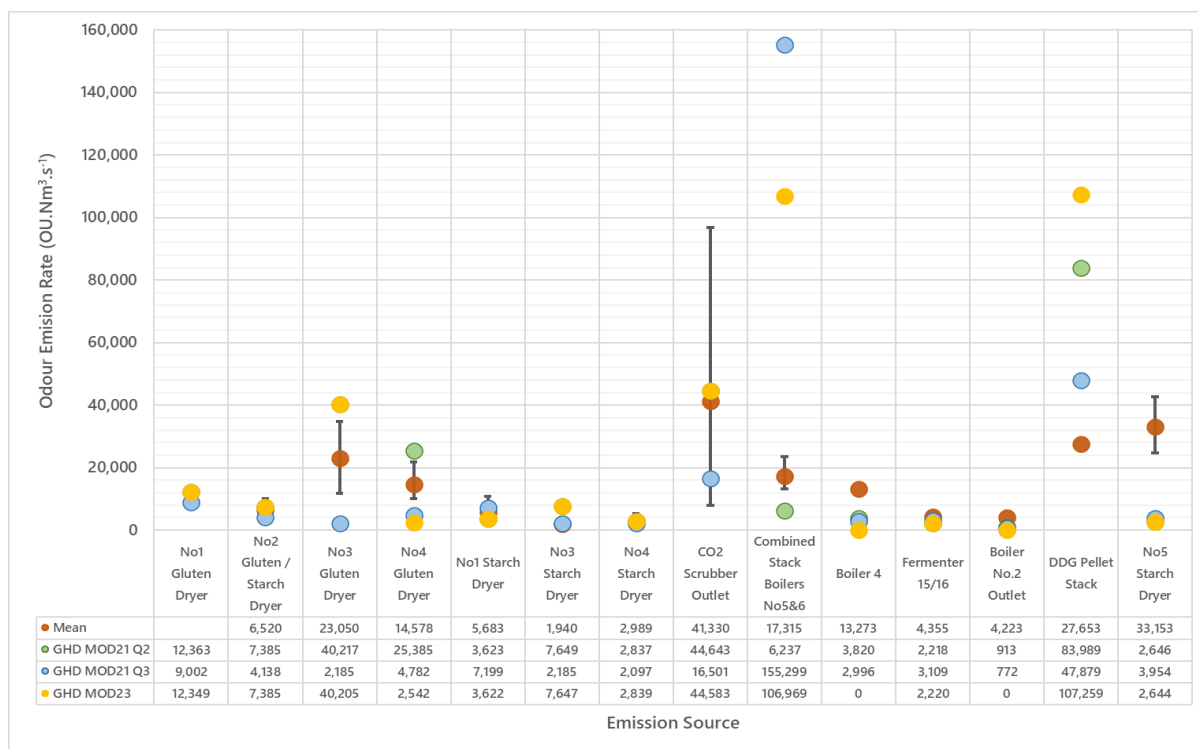
Figure 3 Comparison of measured and modelled odour emission rates

The distribution of the measured and modelled odour emission rates is presented in **Figure 3**.

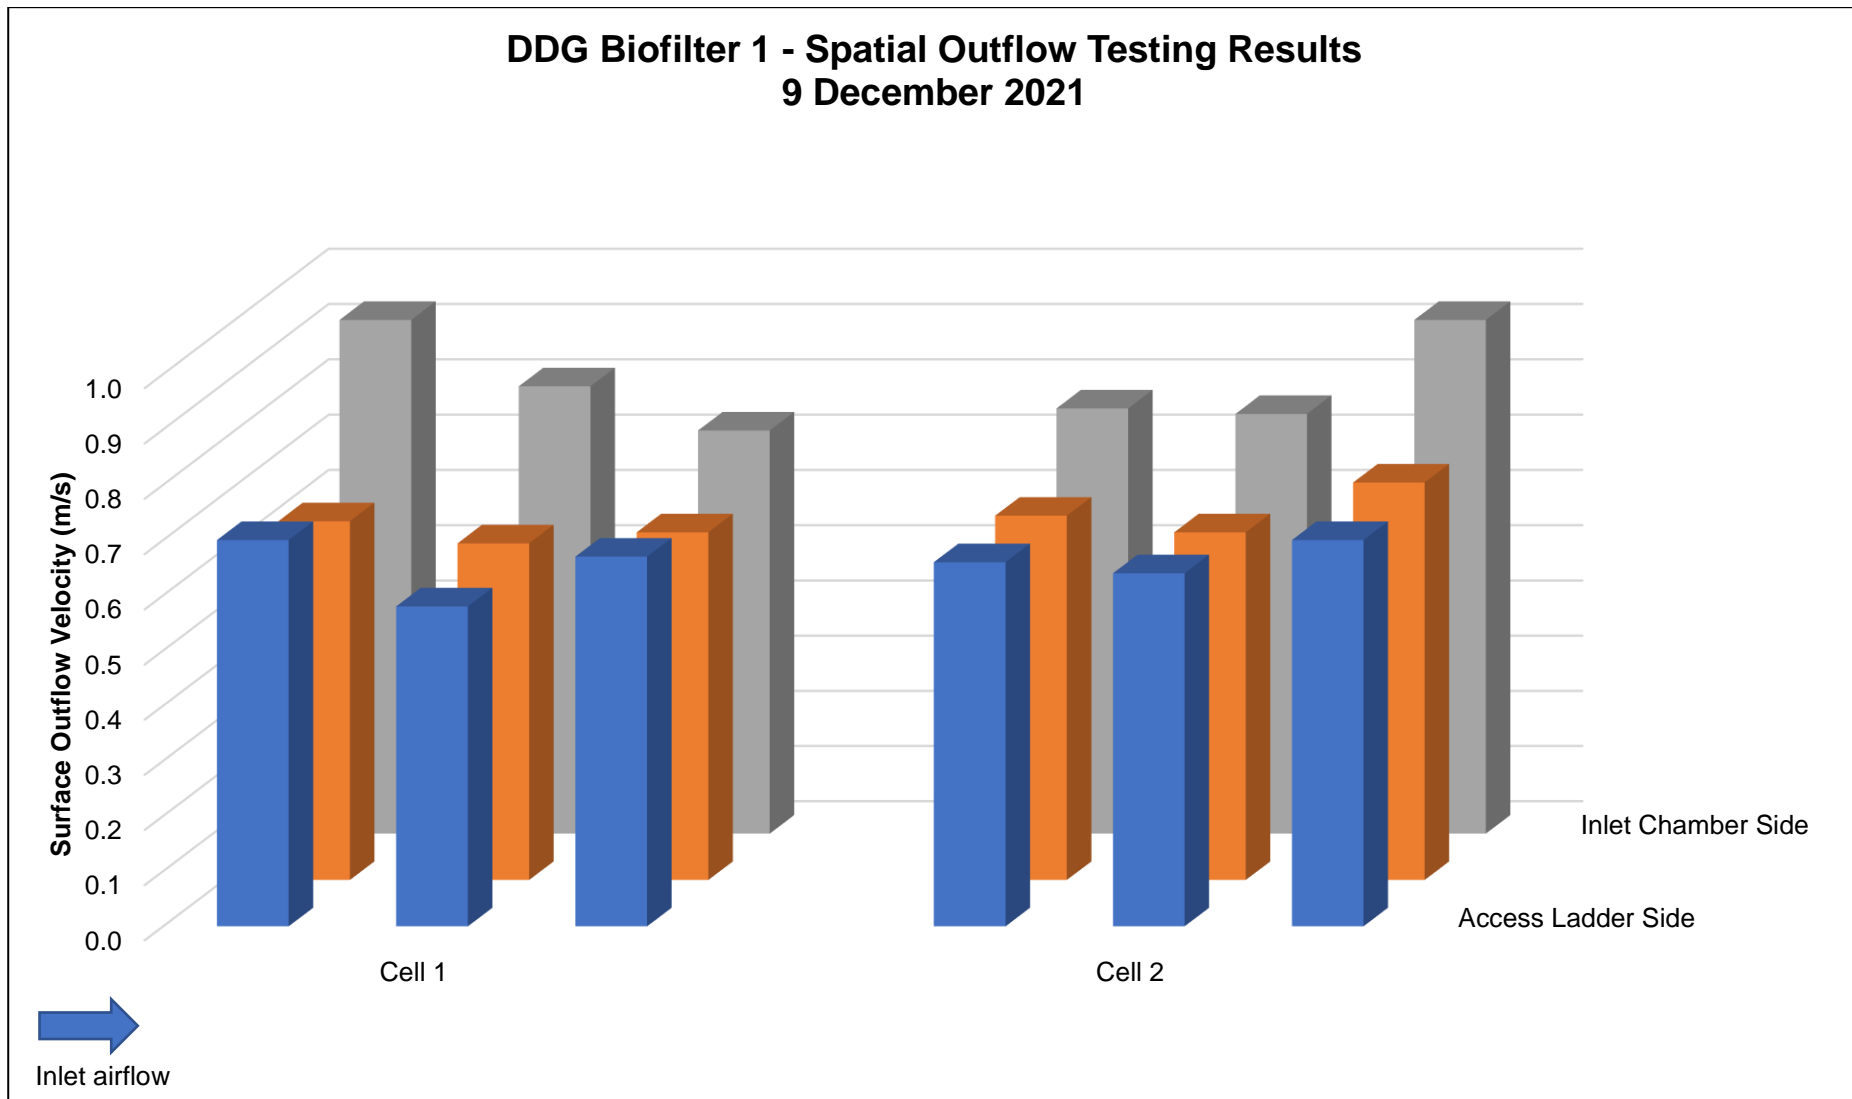
Figure 5.3 – Biofilter 1: Spatial Outflow Testing Results on 9 December 2021

Biofilter Cell	Location ID	Outflow Velocity (m/s)	Mean Outlet Temperature (°C)
Cell 1 (Northern Cell)	Location 1	0.93	Refer to Section 4
	Location 2	0.81	
	Location 3	0.73	
	Location 4	0.65	
	Location 5	0.61	
	Location 6	0.63	
	Location 7	0.70	
	Location 8	0.58	
	Location 9	0.67	
Cell 2 (Southern Cell)	Location 10	0.77	
	Location 11	0.76	
	Location 12	0.93	
	Location 13	0.66	
	Location 14	0.63	
	Location 15	0.72	
	Location 16	0.66	
	Location 17	0.64	
	Location 18	0.70	
Spatial Outflow Statistical Analysis		Cell 1	Cell 2
Average (m/s)		0.70	0.72
Standard deviation (m/s)		± 0.1	± 0.09
Percentage variation (%)		1.5	1.1

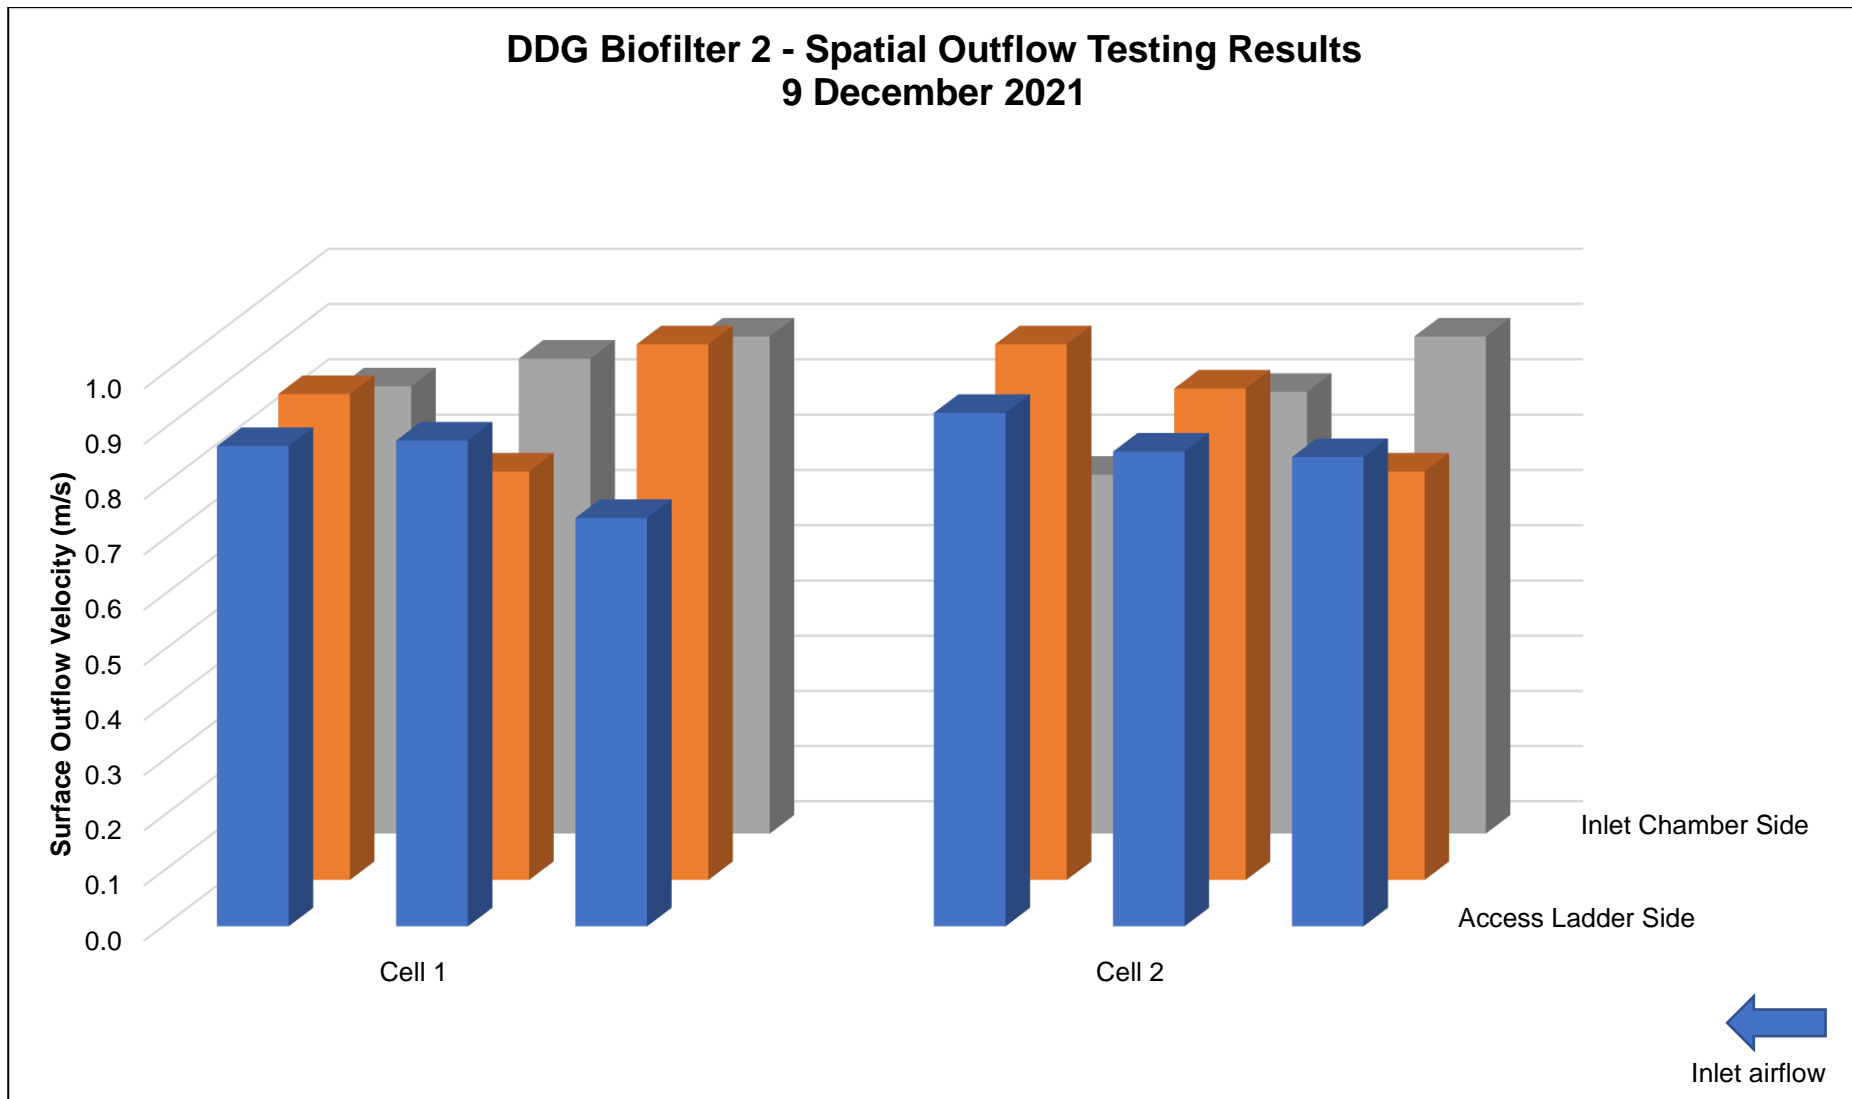
Figure 5.4 – Biofilter 2: Spatial Outflow Testing Results on 9 December 2021

Biofilter Cell	Location ID	Outflow Velocity (m/s)	Mean Outlet Temperature (°C)
Cell 1 (Southern Cell)	Location 1	0.81	Refer to Section 4
	Location 2	0.86	
	Location 3	0.90	
	Location 4	0.88	
	Location 5	0.74	
	Location 6	0.97	
	Location 7	0.87	
	Location 8	0.88	
	Location 9	0.74	
Cell 2 (Northern Cell)	Location 10	0.65	
	Location 11	0.80	
	Location 12	0.90	
	Location 13	0.97	
	Location 14	0.89	
	Location 15	0.74	
	Location 16	0.93	
	Location 17	0.86	
	Location 18	0.85	
Spatial Outflow Statistical Analysis		Cell 1	Cell 2
Average (m/s)		0.85	0.84
Standard deviation (m/s)		± 0.07	± 0.09
Percentage variation (%)		0.6	1.0

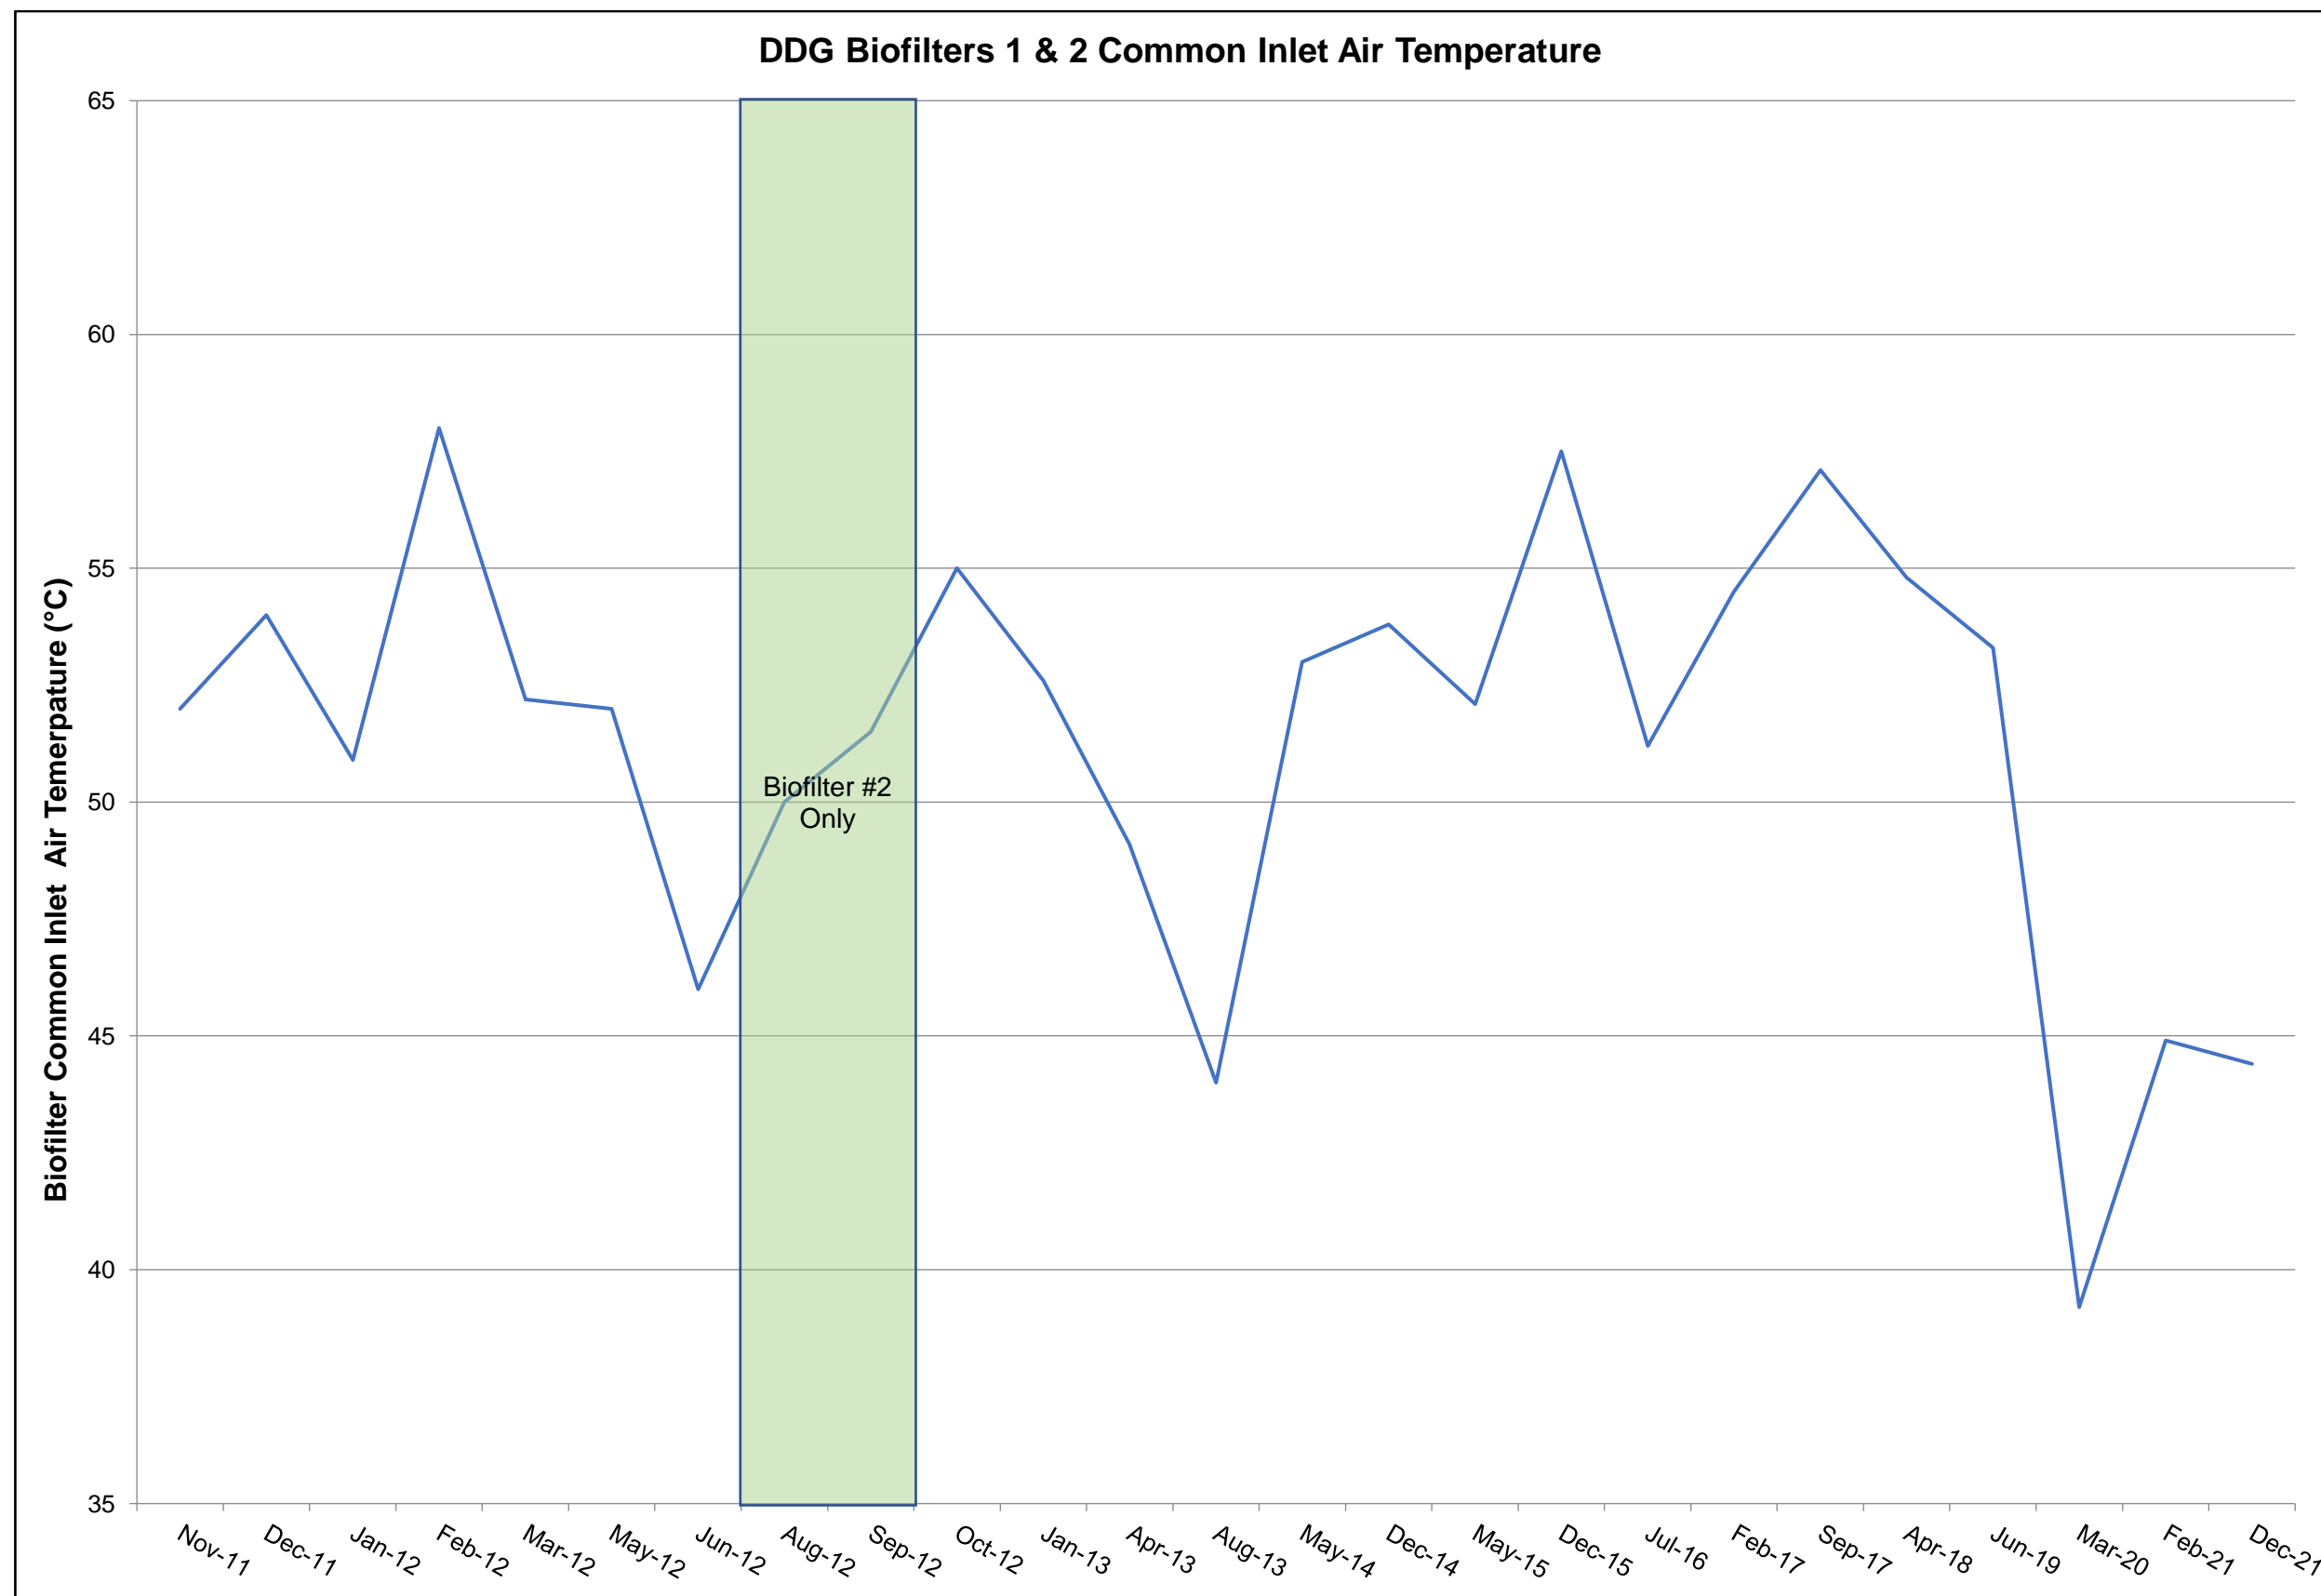
Figure 7.1 – DDG Biofilters 1 & 2 Common Inlet Air Temperature Monitoring

Commencing with the testing results following the commissioning of DDG Biofilter 2 in October 2011, the results of the regular assessments are plotted for key parameters, to identify potentially adverse trends as they occur. These have been plotted as **Figure 7.1** to **Figure 7.5** and include temperature, airflow, back-pressure, and odour concentration, respectively.

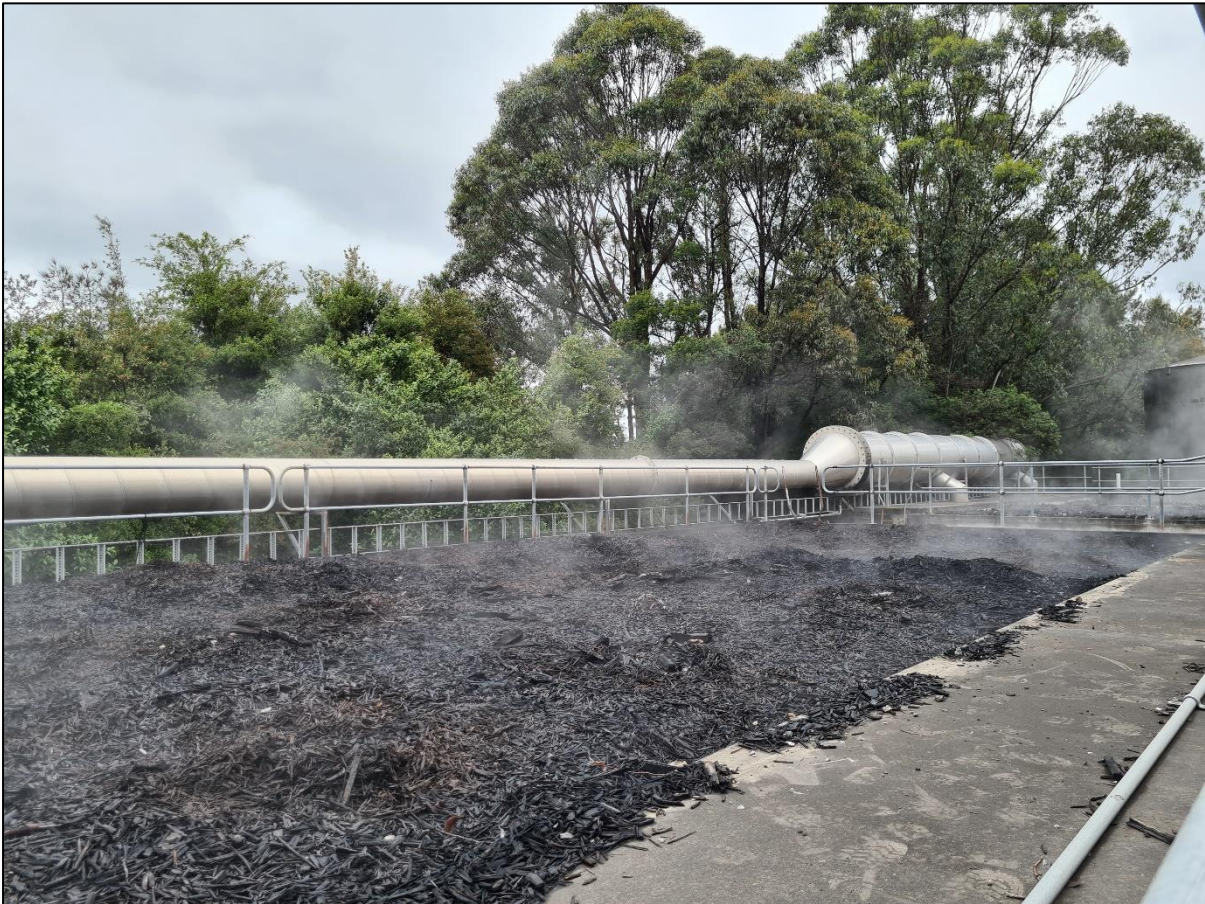
Photo 1 – A view of DDG Biofilter 1 as found on 9 December 2021

The medium in both biofilters, although of different ages, appeared to be in good condition.

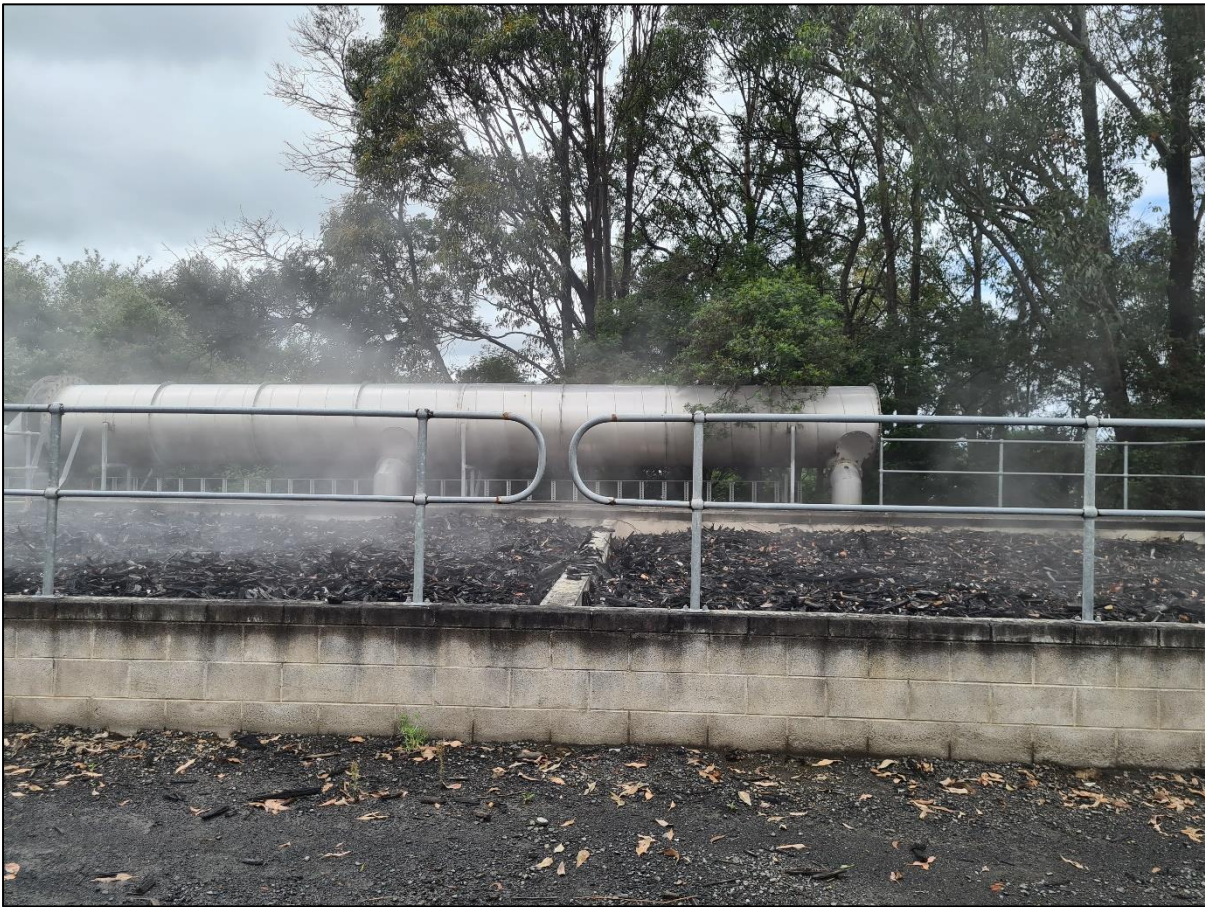
Photo 2 – A view of DDG Biofilter 2 as found on 9 December 2021

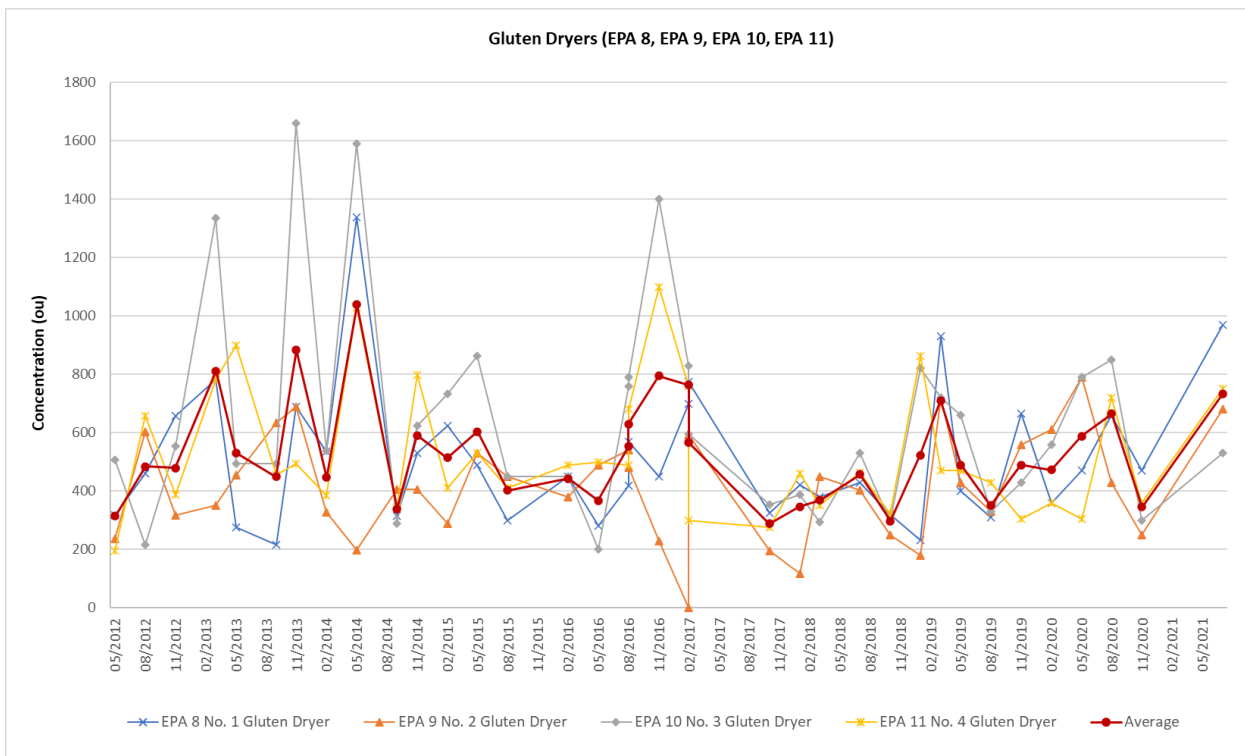
Figure 2. Gluten Dryers No 1,2,3 & 4 (EPA 8, EPA 9, EPA 10, EPA 11)

Zero result represents Dryer not operating on days of testing

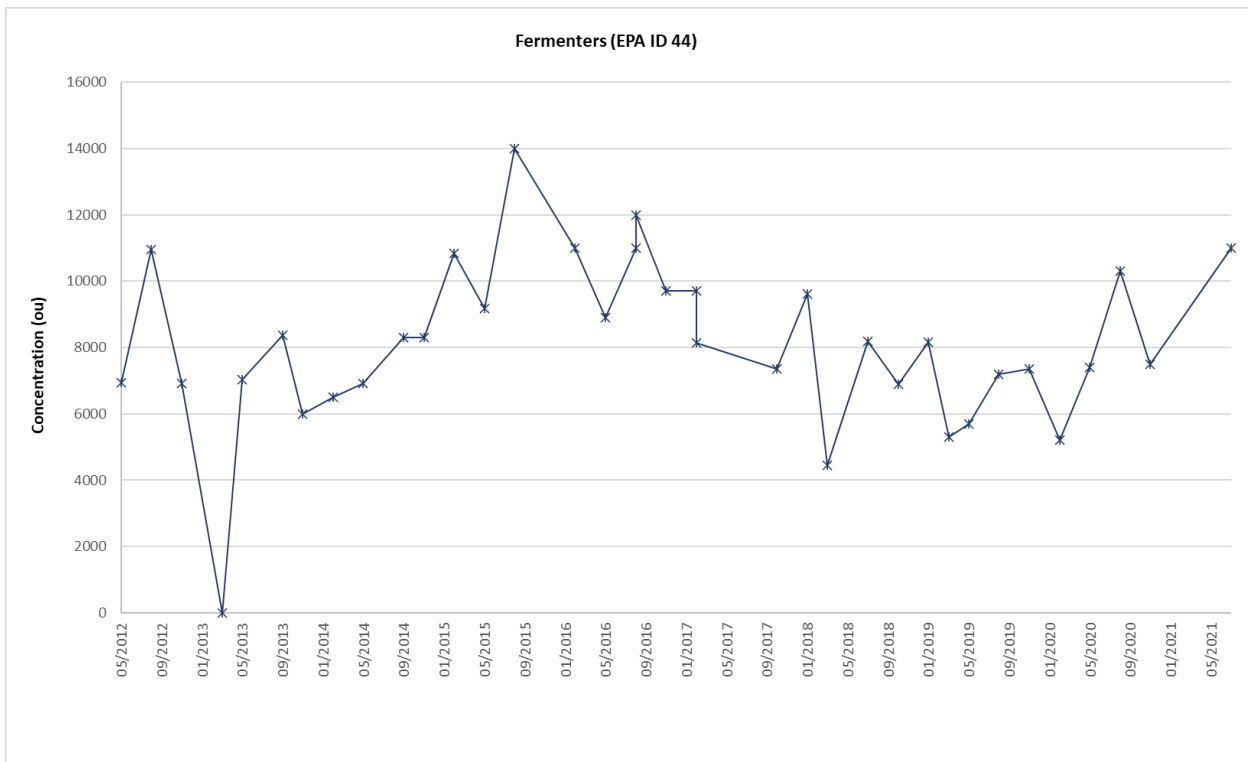
Figure 4. Fermenters (EPA 44)

Zero result represents Fermenter not operating on days of testing

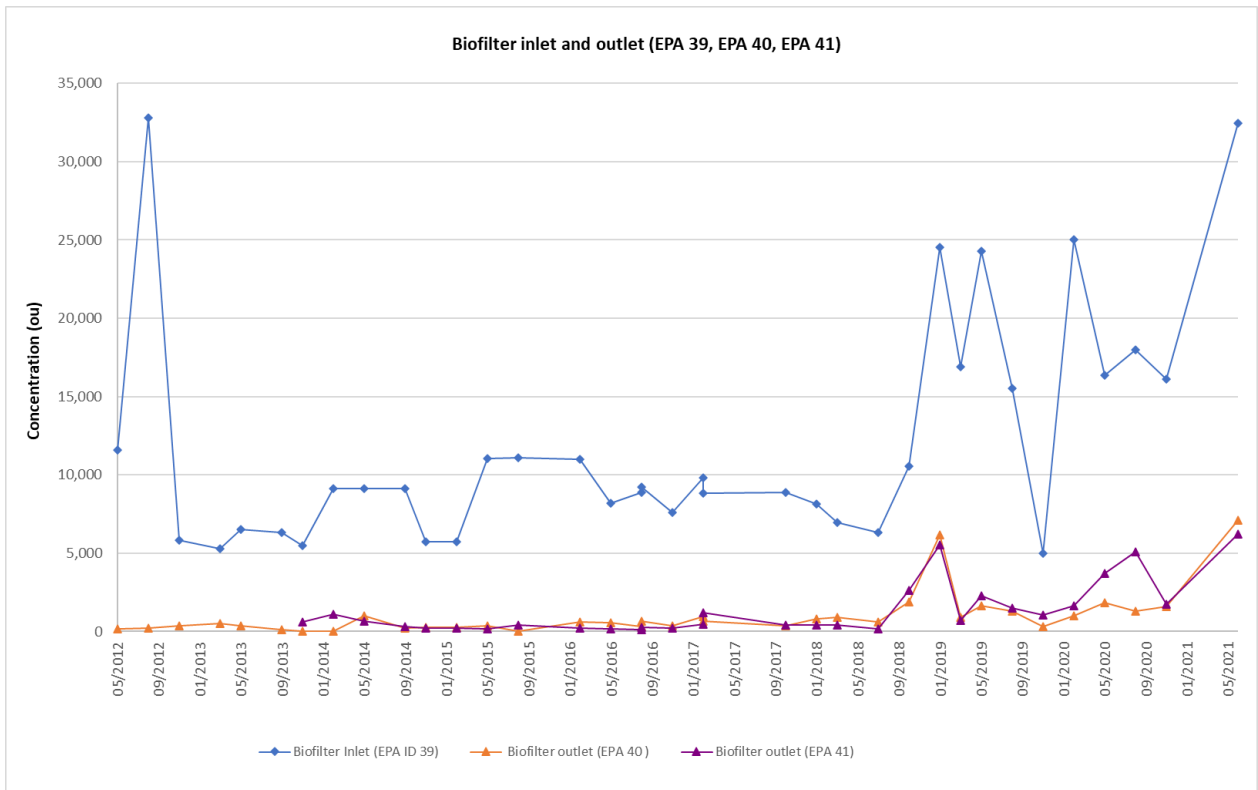
Figure 9. Biofilters (EPA 39,40, 41)

Zero result represents Biofilter not available to be sampled for that event

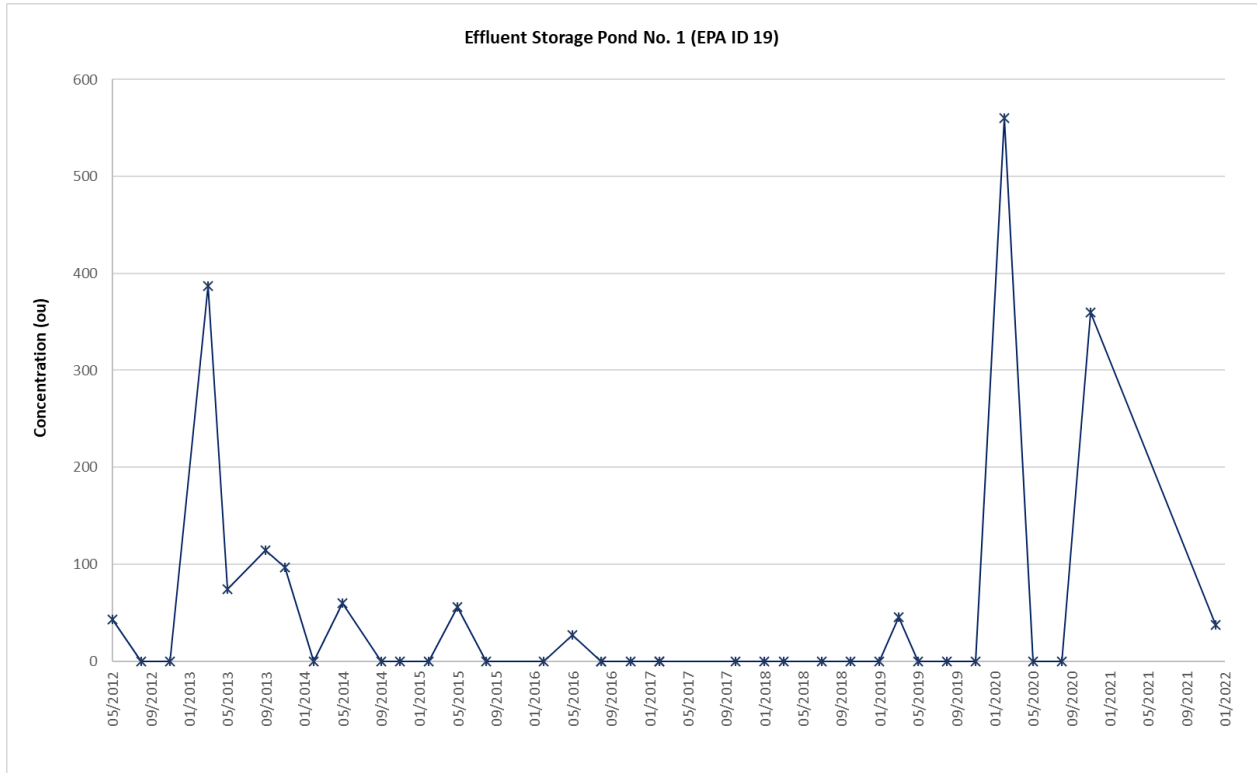
Figure 10. Effluent Storage Pond No. 1 (EPA 19)

Zero results represent insufficient volume to perform sampling.
